Lessons, Successes, and Challenges from the Rehabilitation of East Bank GFS

Thokozani Kaitane
April 2021

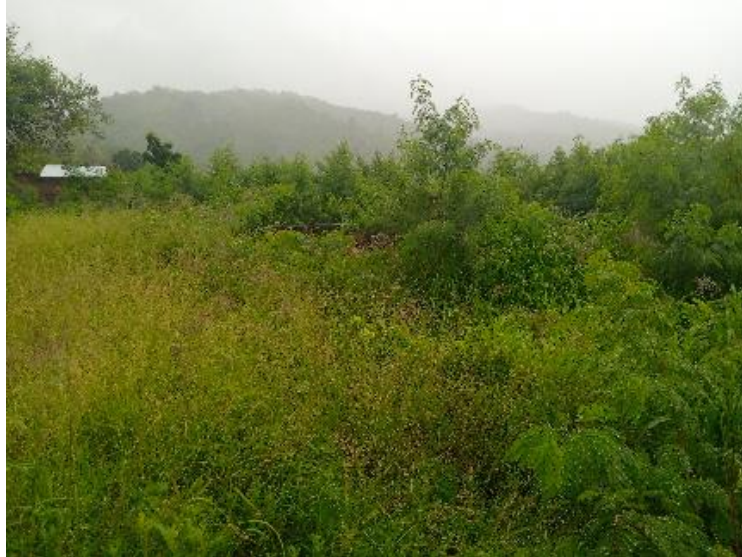
Mbadzi water treatment works outgrown by grass

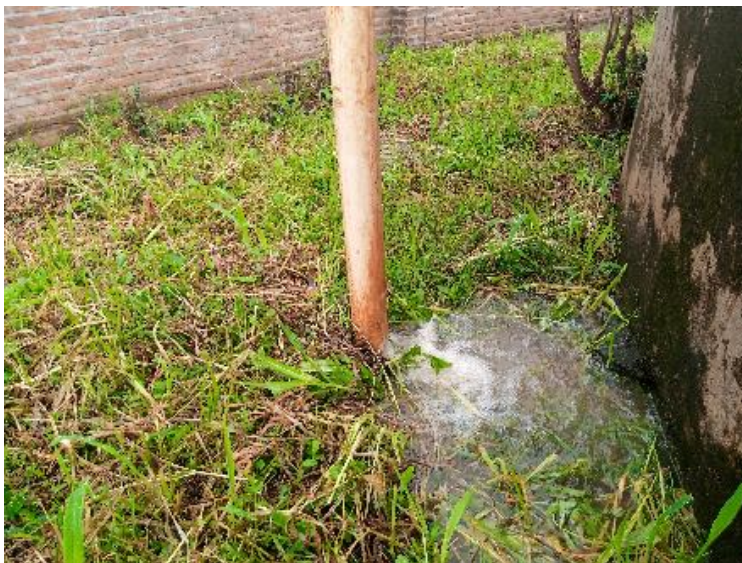
Lack of leadership and ownership of the schemes has been identified as one of the key challenges affecting smooth operations of the systems. Ideally, the operations of the schemes are entrusted with the Water User Association (WUA) through the various scheme committees. The WUA and scheme committees are supposed to be supervised by the District Water Development Office. On the ground, not much effort is given to the ownership of the scheme, leading to unattended faults, vandalism, and an unkept look of the schemes.

An unattended fault at Mbadzi
