## **Wetland Restoration as Part of an IWRM Approach to Ensuring Sustainable Supply of Water Resources: A Case of Kamwenge District in Uganda**

**Grace Kanweri**, [gkanweri@waterforpeople.org](mailto:gkanweri@waterforpeople.org)  
**Stanley Okettayot**, [sokettayot@waterforpeople.org](mailto:sokettayot@waterforpeople.org)  
**Cate Nimanya**, [cnimanya@waterforpeople.org](mailto:cnimanya@waterforpeople.org)  
**Water for People Uganda**  
**July 2019**

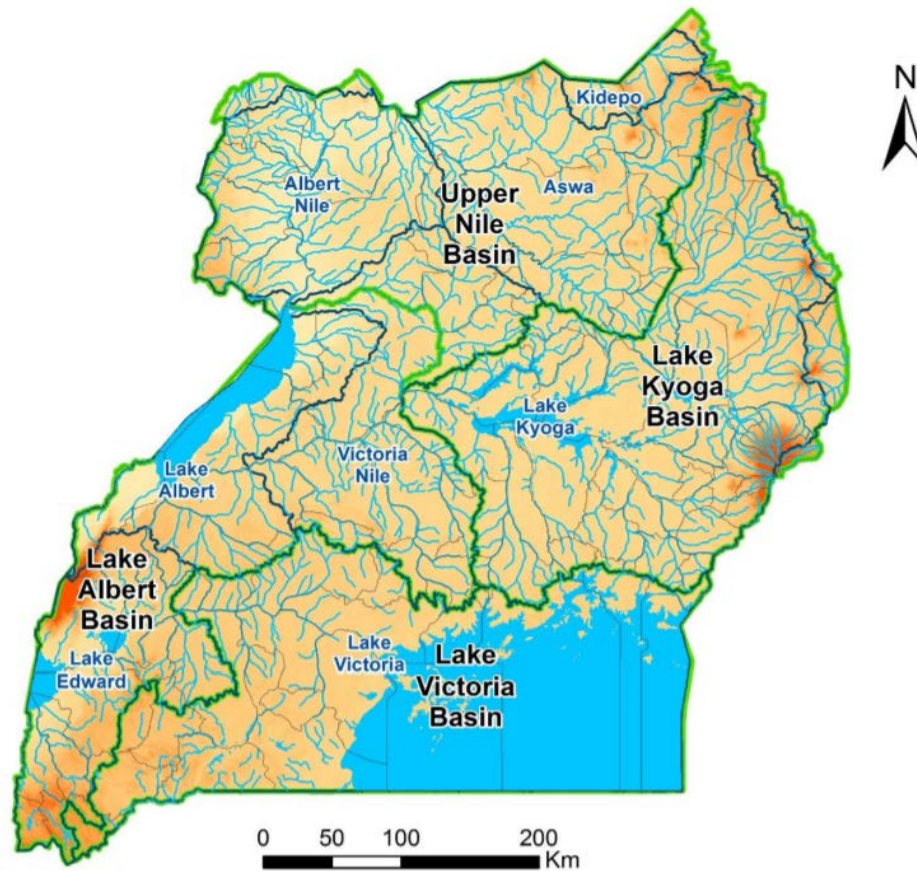
**Figure 1: Map of Uganda showing the 4 major basins on whose hydrological flow the Albert, Victoria, Upper Nile, and Kyoga Water Management Zones (WMZs) delineation is based**

Although there was a 0.03% increase in the Uganda wetland area in the year 2014, it is far less proportionate to the 30% reported decline between 1994 and 2008 (Government of Uganda, 2016). The extent of degradation or decline in wetland coverage varies across the four primary basins in Uganda: Lake Victoria, Lake Kyoga, Lake Albert, and Upper Nile as shown in Figure 1.

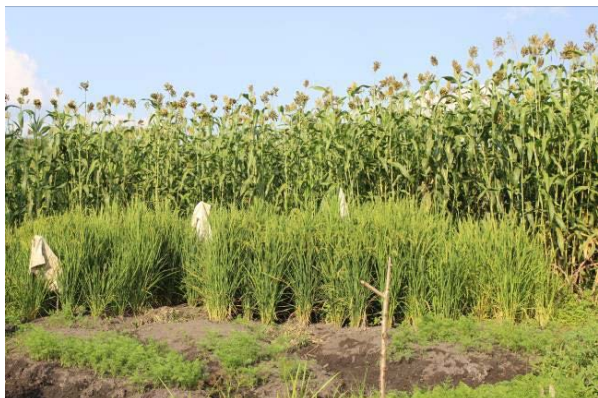
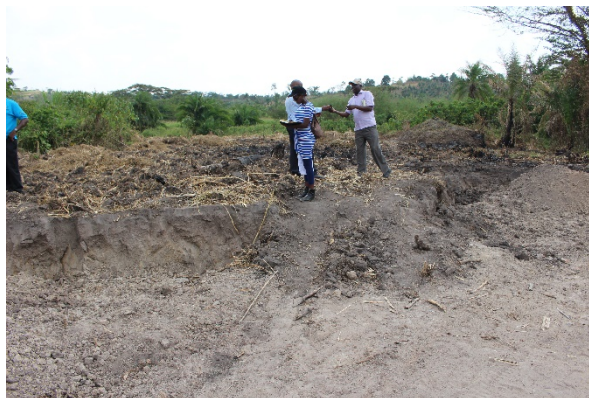
Photos 1 & 2: Rice and sorghum growing (left) and sand mining (right) in Rwakasirabo Wetland before restoration

The degradation was feared to not only affect groundwater potential and related failure of the water systems’ ability to last up to their design period, but also other human and environmental benefits of such ecosystems with diversity of flora and fauna like fish, which was of key value to the population in the vicinity. In addition, the wetlands and fragile ecosystems are meant to be a public good that provides a diversity of uses to different users and stakeholders, yet they were being personalized by the degraders (Ministry of Natural Resources, 1995). Water draining trenches and alien plant species, mainly crops (photo 1) and trees, were introduced to the sensitive ecosystems thus reducing the wetlands’ ability to perform their natural functions of filtration, flood control, aquifer replenishment, and providing habitat to wetland adapted flora and fauna. Intensive sand mining which left deep pond like holes (photo 2), in mainly the Rwakasirabo Wetland, punctuated the fragile ecosystems exposing them to drying up through evaporation. Restoration of the wetland became an immediate need for the sustainability of the piped water supply infrastructure.

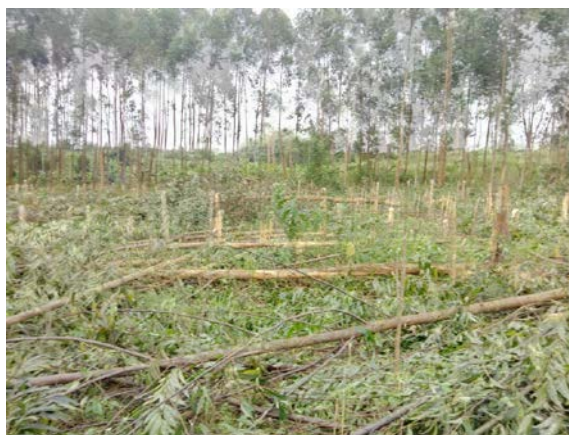
*Photos 3 & 4: The RDC addressing the SEO, DPC, and OC Biguli Police station during enforcement to remove illegal activities (left) and eucalyptus cleared by enforcement in Rwakasirabo Wetland (right)*

Additionally, it is within the mandate of the local governments to actively manage and coordinate the conservation efforts of the natural resources within their territories through planning, management, and enforcement, including eradication of illegal activities through policing (Government of Uganda, 2016). Following this mandate, in areas where noncompliance was noticed despite the sensitization, the District Natural Resources and Senior Environment Officers (SEO) served the culprits with restoration orders. For those that did not comply or cease illegal activities, joint enforcement was done by teams of staff from the offices of the Chief Administrative Officer (CAO), Resident District Commissioner (RDC), District Chairperson, District Police Commander (DPC), District Internal Security Officer (DISO), and the Biguli Sub County Chief and Chairperson. During the enforcement, eucalyptus trees were cut down, crops were cleared, and water draining channels were covered up to enable regeneration.

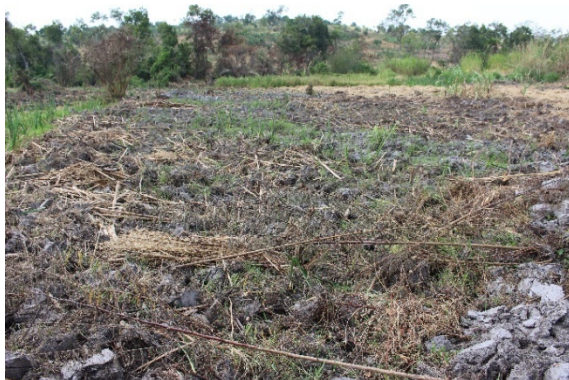
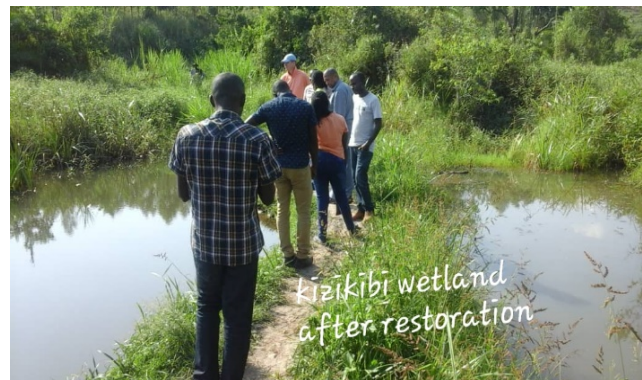
*Photos 7 & 8: Kizikibi Wetland before (left) and after restoration (right)*

- Five wetlands have fully been restored.** These include Rwakasirabo, Kizikibi, Nyakatooma, Kabale, and Keishunga Wetlands in Biguli Sub County. The wetlands are fully flooded with water and overgrown with wetland vegetation. In Kizikibi, there are mud fish which had totally been extinct when the wetland was a hub of human activities. Neighboring communities are fishing and enjoying the fish protein from the restored wetland.

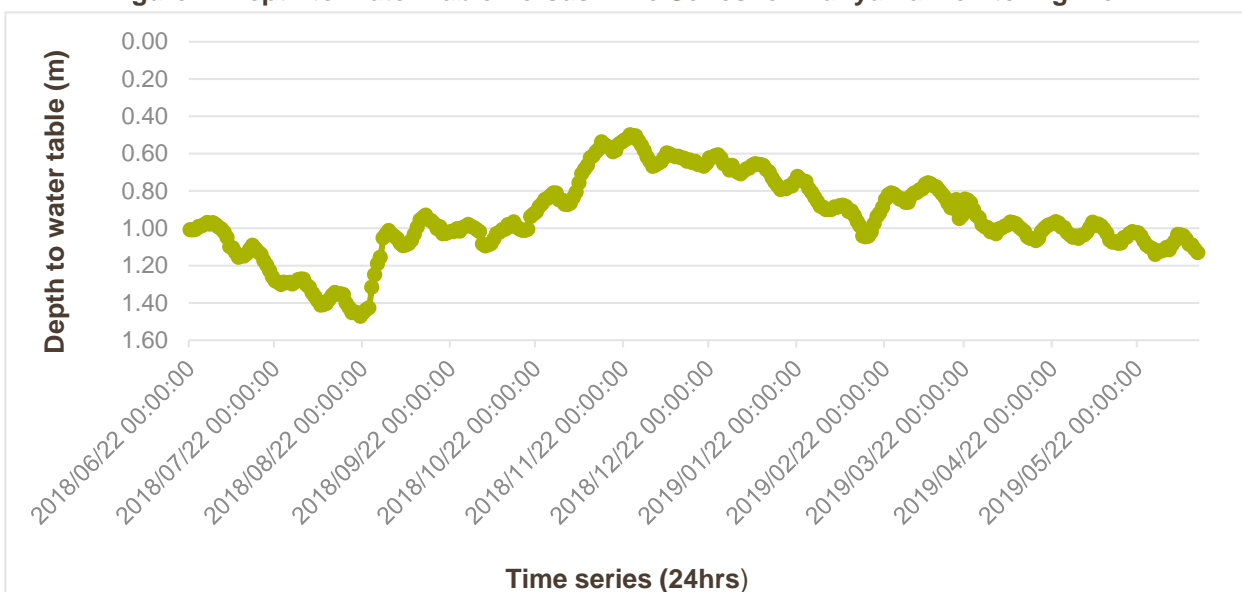
**Figure 4: Depth to Water Table Versus Time Series for Munyuma Monitoring Well**

6. **Groundwater monitoring has improved understanding of groundwater level fluctuations throughout the year and the importance of wetland restoration for improving recharge and subsequent system sustainability.** Monitoring results are available for 1 year, and the results are presented in Figure 4. Findings have been shared on various platforms, including Uganda Water and Environment Week in Entebbe and the bi-annual learning event in Kamwenge District. From the findings, most of the drilled wells in Biguli Sub County consist of unconfined aquifer which highly depends on precipitation for recharge. This was observed from the variation in the groundwater level in relation to the rainfall seasons of the year with the water table level rising during rainy season and dropping slightly during rainfall off seasons. This implies that sustaining recharge throughout the year requires a system that holds the surface runoff that flows during rainy season to ensure constant recharge during the rainfall off seasons. Thus, this highlights the need to restore the wetlands, since it has the capacity to hold the surface runoff that ends up in it for a considerably long time to recharge the wells even during the rainfall off seasons.

With only 1 year of data and limited data from before the wetland work began, it is not possible to quantify the exact impact of the wetland restoration in terms of reduction in water level declines. However, the declines observed in the dry season in 2019 were slight, which could be attributed to the rejuvenating wetlands. Figure 4 presents a result of depth to water table below ground level (m) against a time series (24 hours) from the Munyuma monitoring well, indicating the gradual fluctuation in the level in accordance with the rainfall pattern in Biguli.

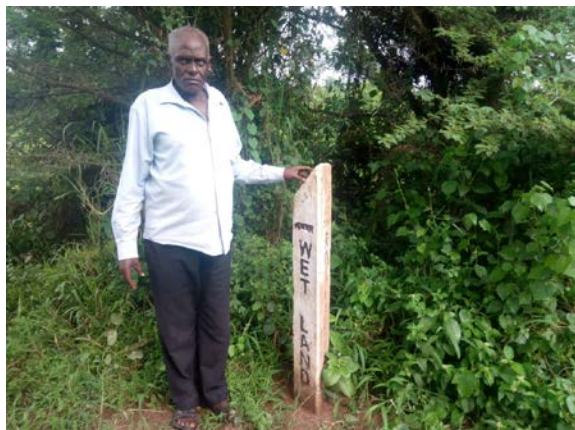
*Photos 11 & 12: District Councilor, Mr. Karaki, beside a pillar marking the boundary of Rwakasirabo Wetland to which he is a major frontline land owner (left) and a pillar standing out on the boundary of the restored Rwakasirabo Wetland (right)*

The degraded area size of the 5 wetlands in Biguli was measured and established to be 98.34 acres. The next step was to back up the live marks with reinforced concrete pillars for permanent boundary marking. So far, 3 wetlands of Kizikibi, Nyakatooma, and Rwaksirabo have their boundaries fully demarcated with the permanent reinforced concrete pillars for frontline communities to know the buffer zones within which to avoid degrading activities or implement regulated activities. Placement of permanent reinforced concrete marks was done at an interval of about 100m from one pillar to another along the boundary line of the wetlands.

2. **Demarcation of more wetlands.** There is need to have the other delineated wetlands demarcated with permanent markers, preferably using the reinforced concrete pillars. Water levels and lines of the wetlands tend to shift over time along with the seasons, and this can often affect the sustainability of conservation and restoration achievements. Communities need to permanently know where the boundary of the wetland lies so that they can avoid degrading forever.
