## BUILDING CLIMATE RESILIENCE THROUGH PROTECTION OF WATER SUPPLY SOURCES:

### Case of Rulindo and Gicumbi Districts

## WETLAND RESTORATION AS PART OF AN IWRM APPROACH TO ENSURING SUSTAINABLE SUPPLY OF WATER RESOURCES: *A case of of Kamwenge District in Uganda*

# BUILDING CLIMATE CHANGE RESILIENT WASH STRUCTURES:

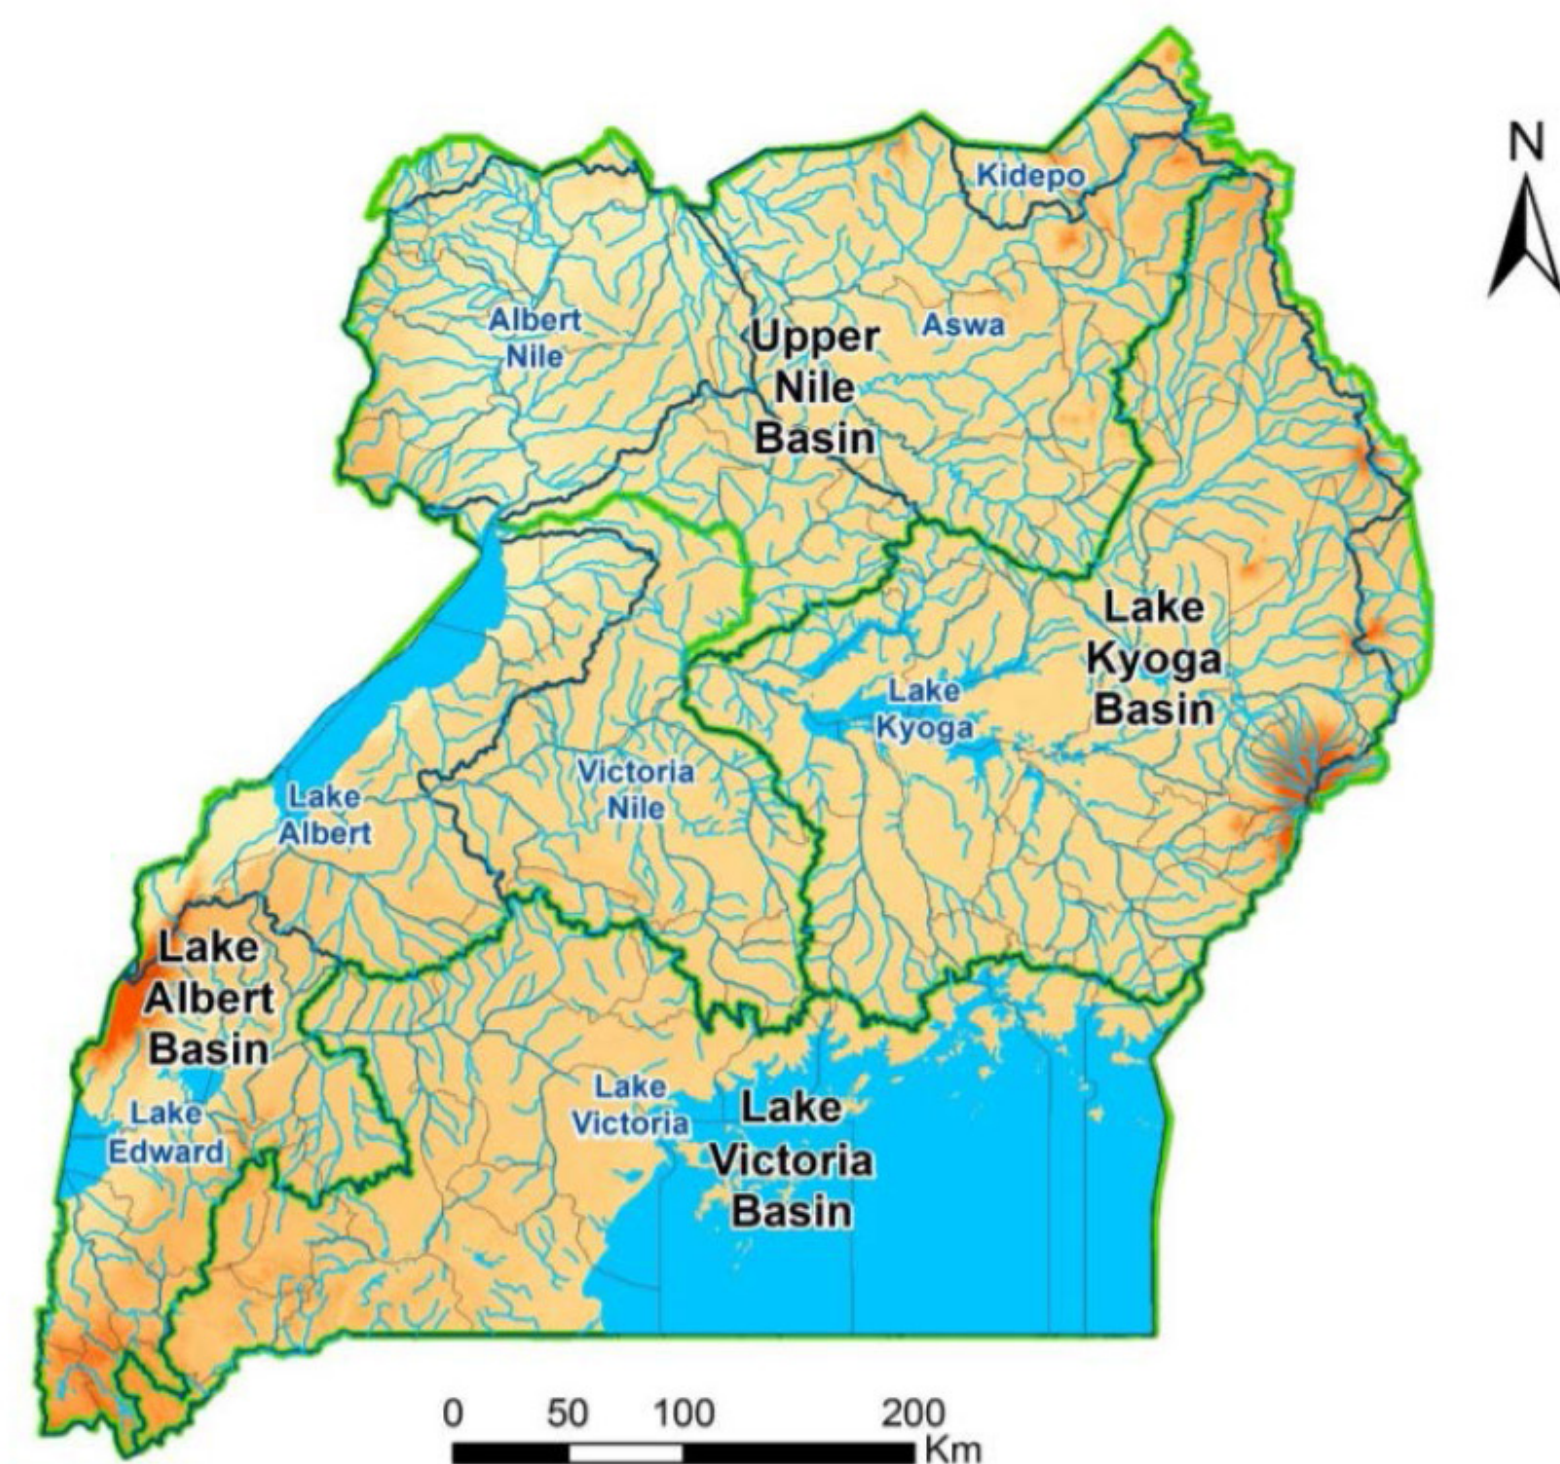
The 4 major basins on whose hydrological flow the Albert, Victoria, Upper Nile and Kyoga Water Management Zones (WMZs) delineation is based

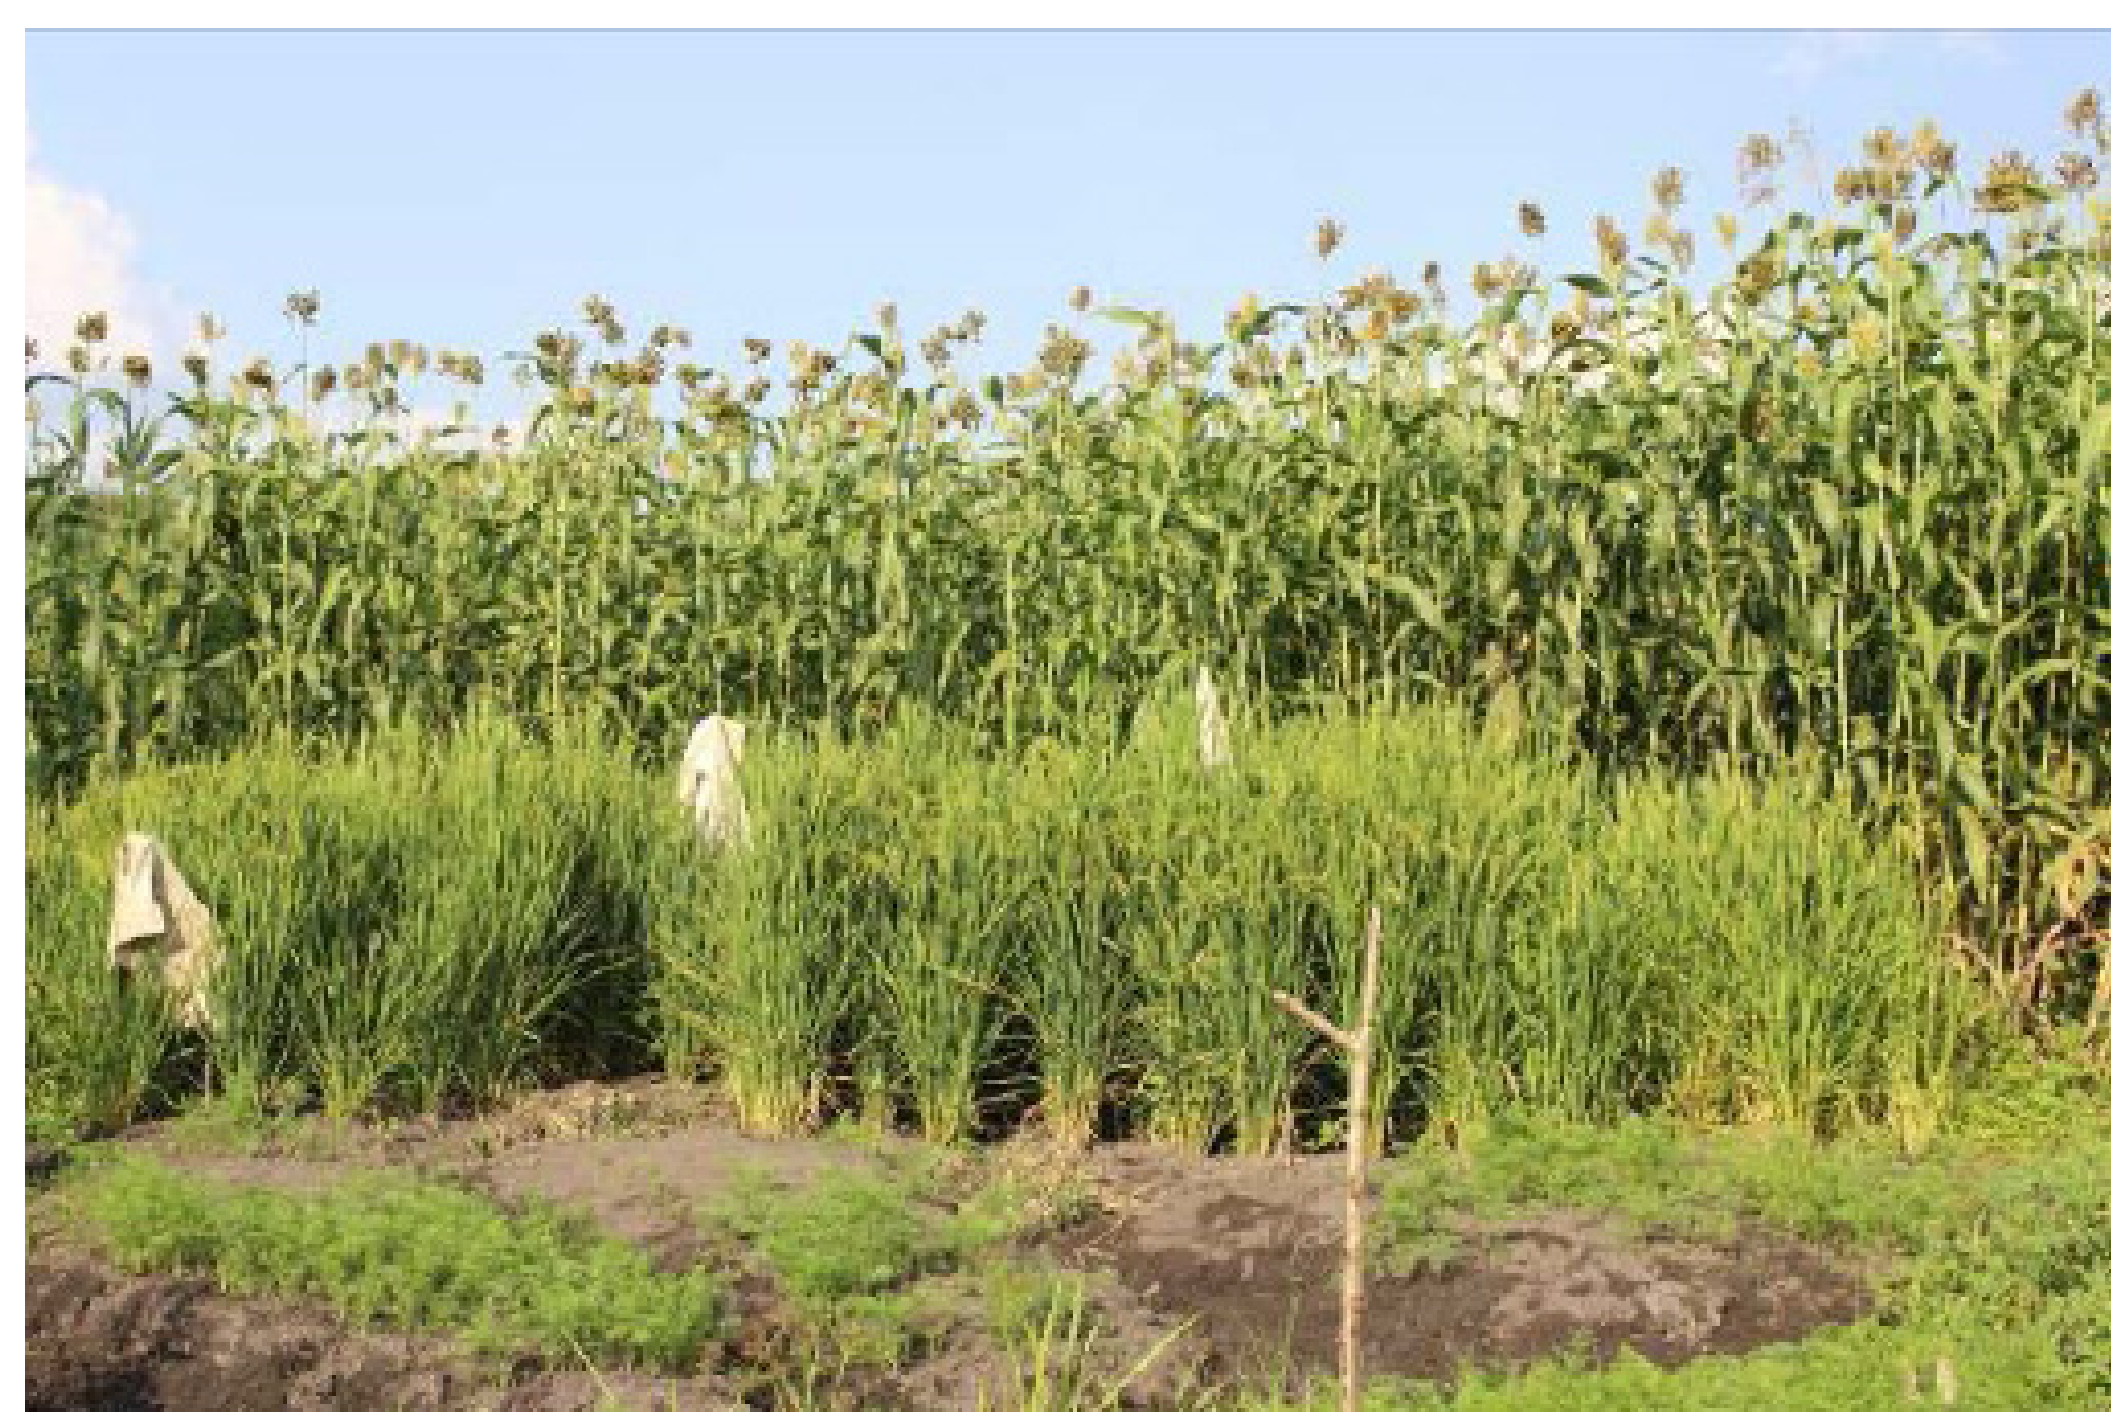
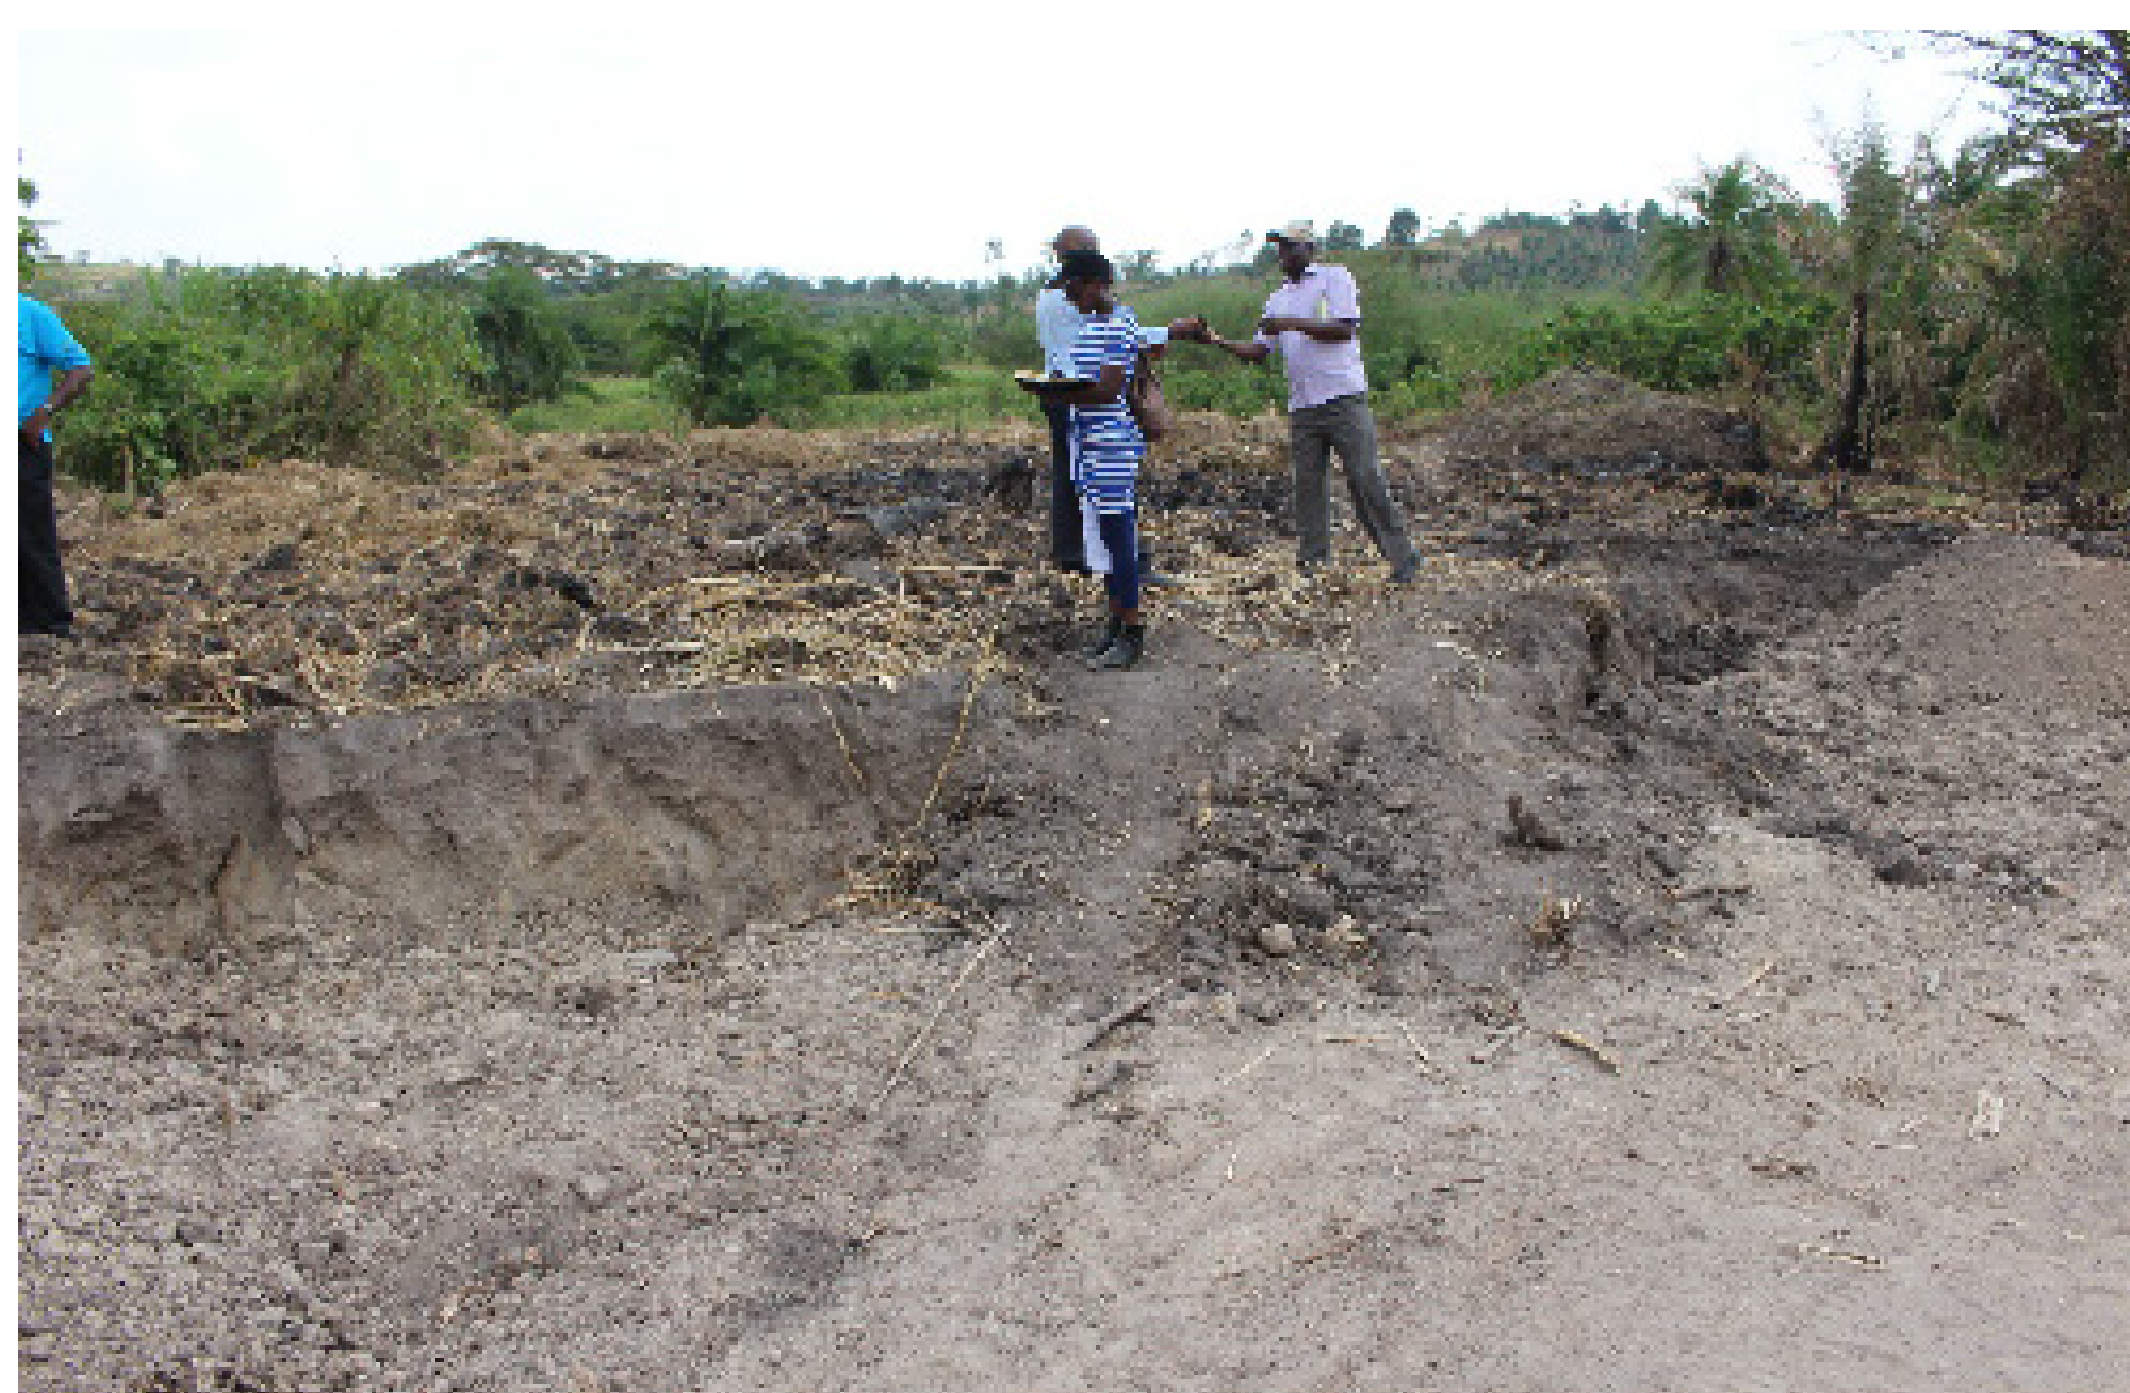
Rice & sorghum growing (Top) and sand mining (down) in Rwakisirabo Wetland before restoration

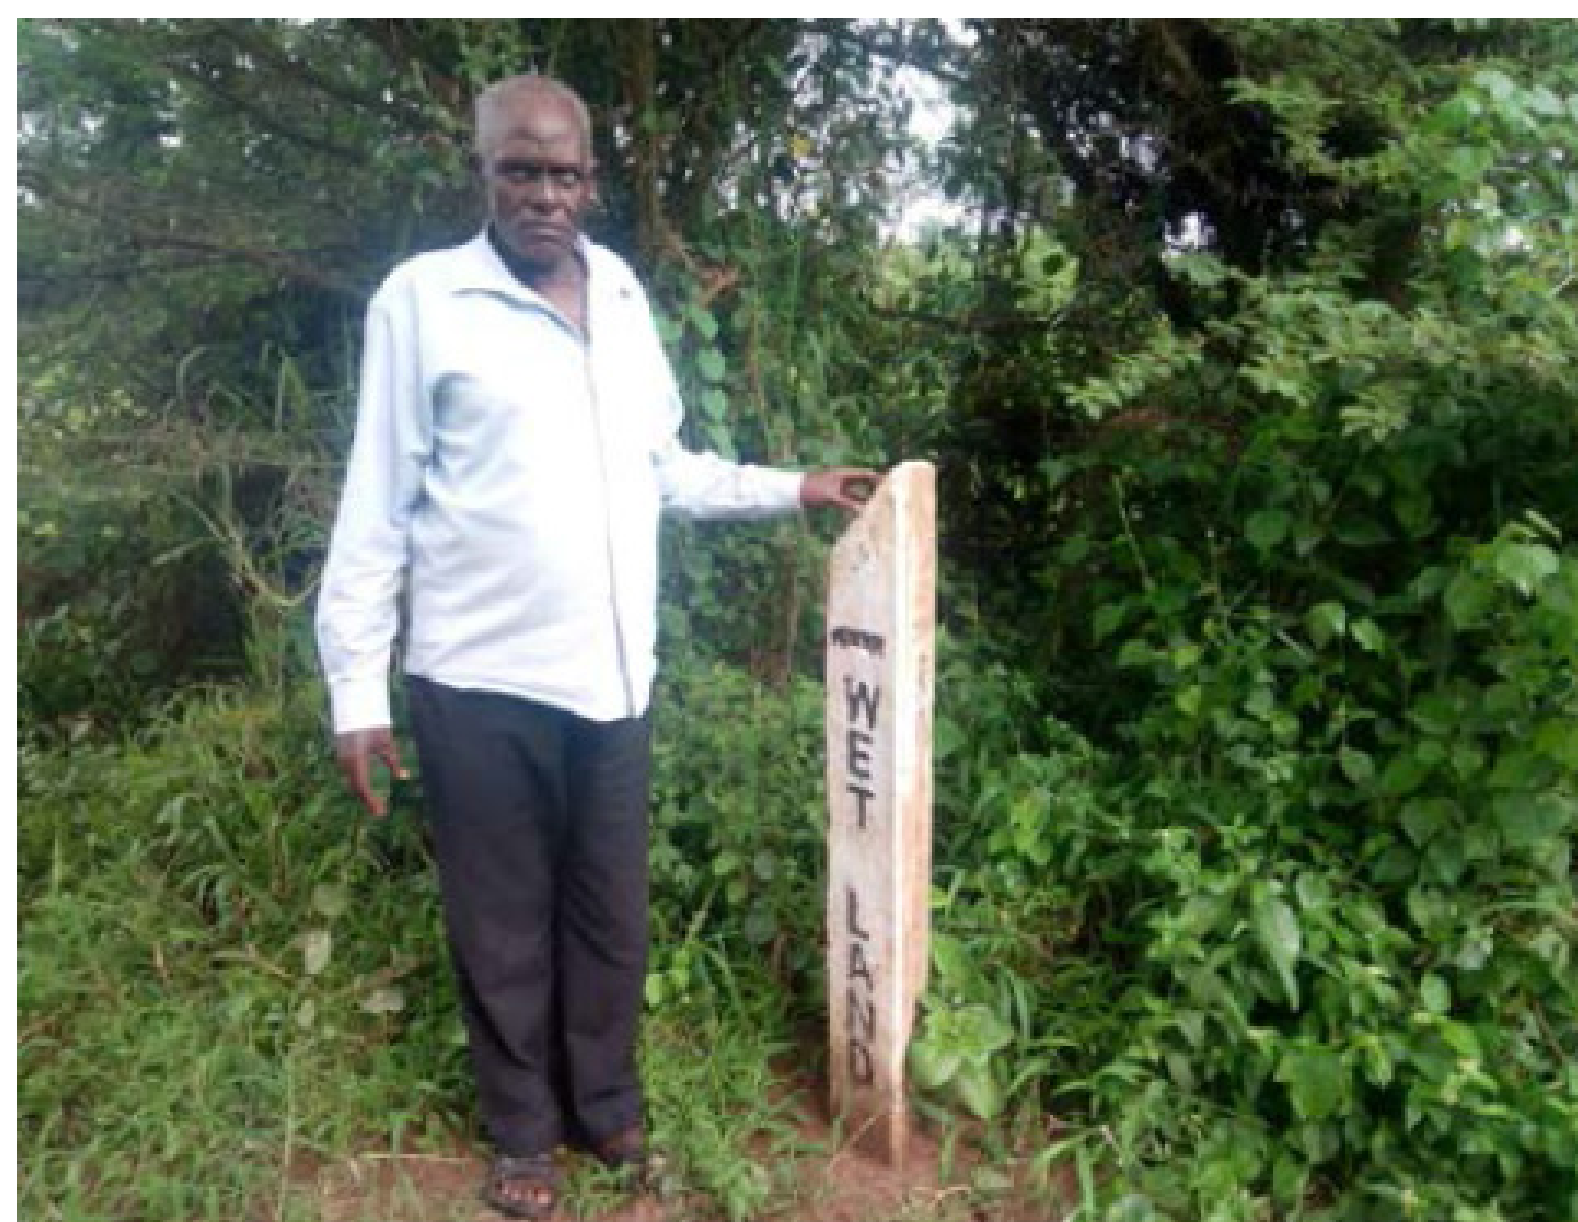
District Councilor, Mr. Kaseki, beside a pillar marking the boundary of Rwakisirabo Wetland to which he is a major frontline land owner

Working with the Ministry of Water and Environment Water For People delineated the wetlands, demarcated wetlands with permanent reinforced concrete pillars, conducted intensive community mobilisation and education to raise awareness on the importance of wetlands on ecosystem health, and educated them on water and soil conservation practices on farm upstream. Enforcement mechanisms were also put in place and started conducting regular groundwater level monitoring to monitor the impact in 25 wetlands

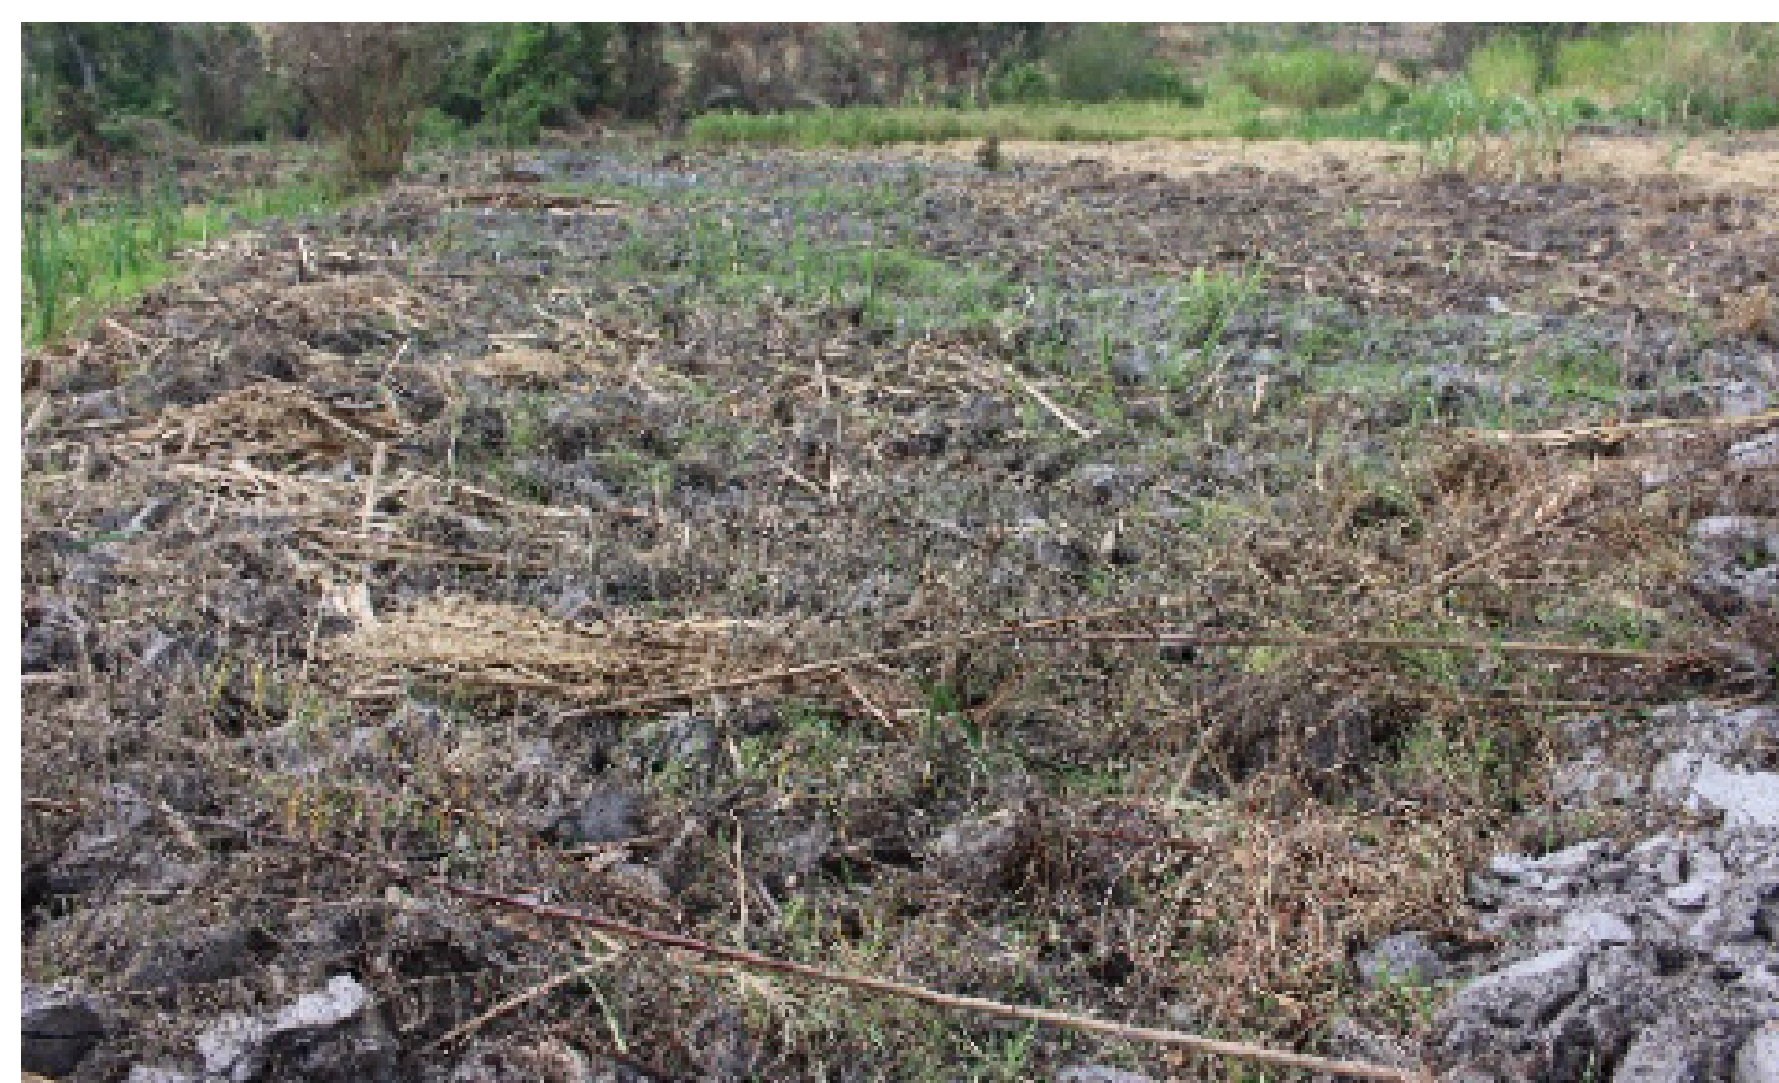
Kizikibi Wetland before (left) and after restoration (right)

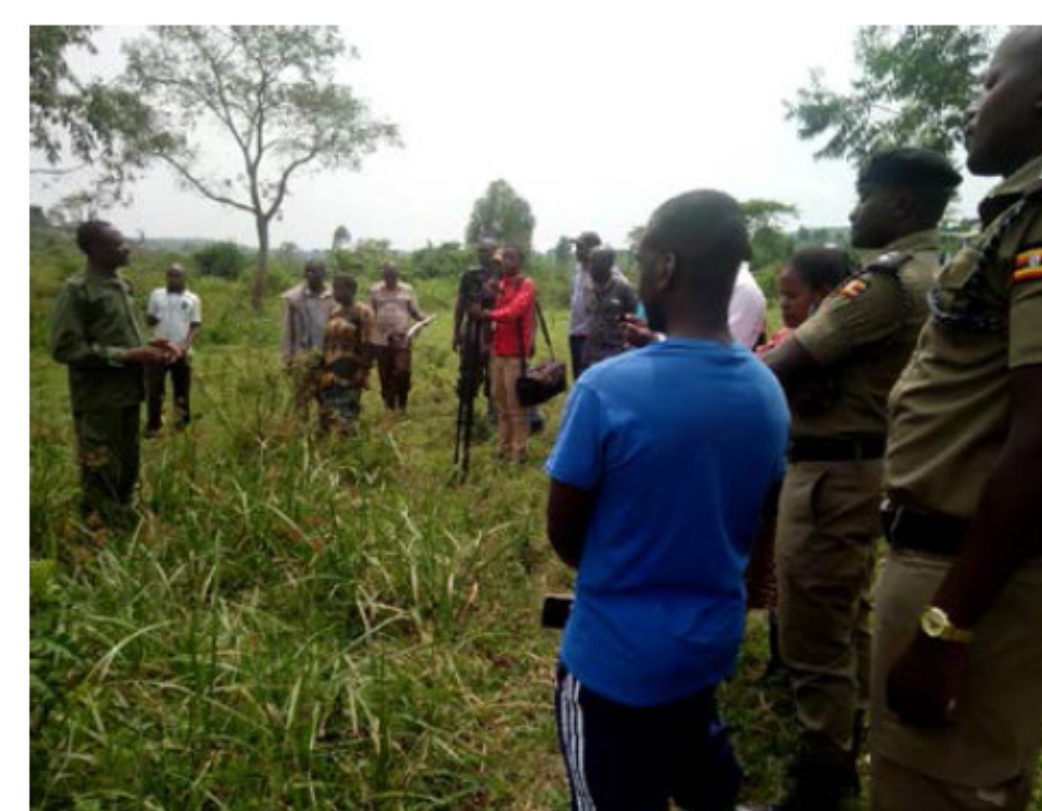
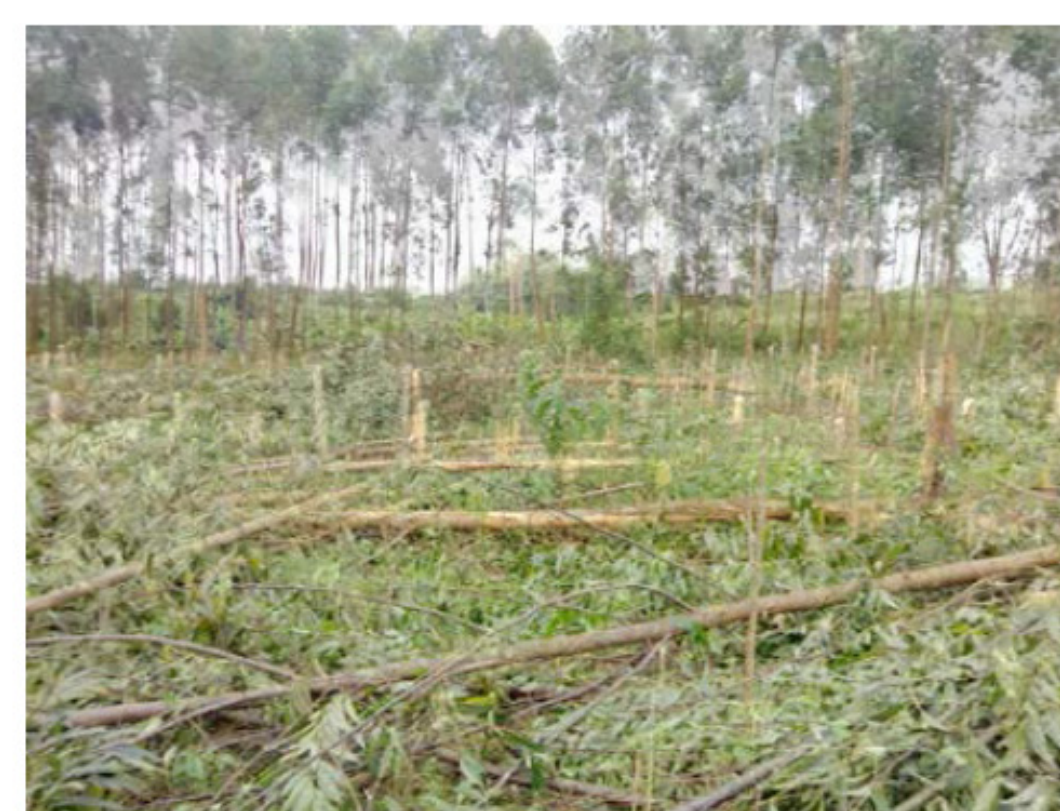
The RDC addressing the SEO, DPC, and CC Biguli Police station during enforcement to remove illegal activities (left) and eucalyptus cleared by enforcement in Rwakisirabo Wetland (right)

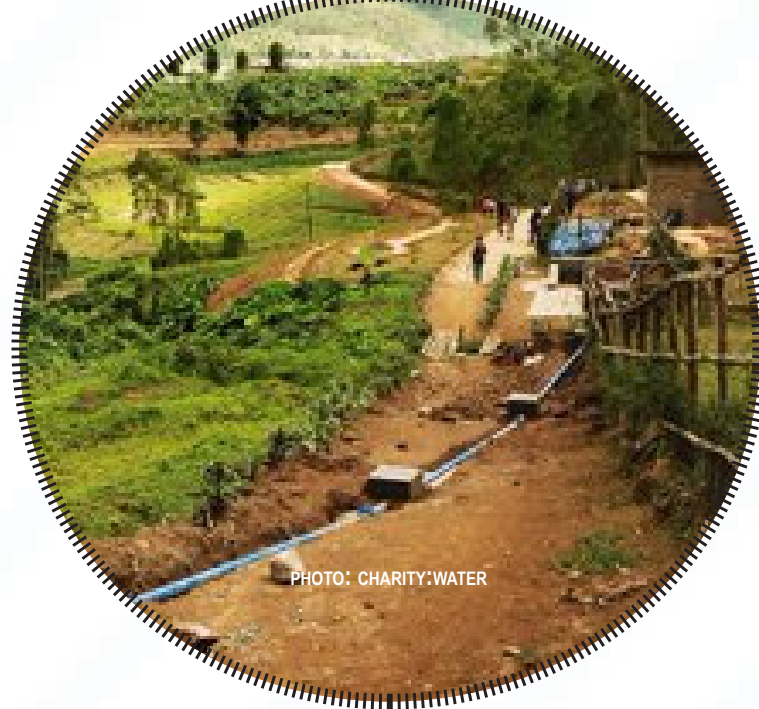
**30 KMs**

of water supply pipelines washed away during Cyclone Idai

In Chikwawa, it is estimated that WASH (Water, Sanitation & Hygiene) infrastructure worth US\$3.8M was damaged during Cyclone Idai that also resulted into a loss estimated at US\$2.1 million. A total of 30 kms of water supply pipeline was washed away, 258 household latrines collapsed, and 396 boreholes were washed away<sup>3</sup>. This is evidenced by the drop in level of service of water supply from 86% in 2018 to 63% in 2019, as shown in the graphs below:

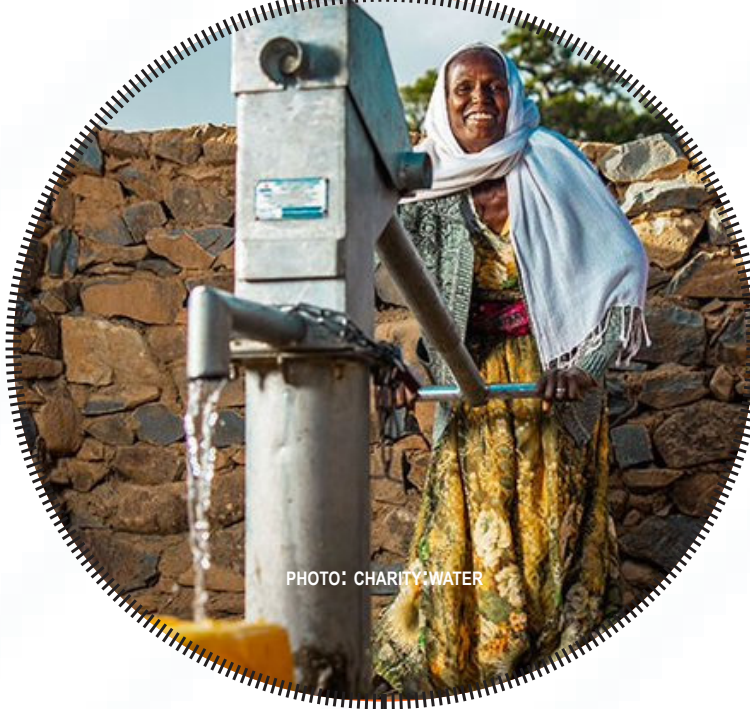
**396**

boreholes washed away during Cyclone Idai

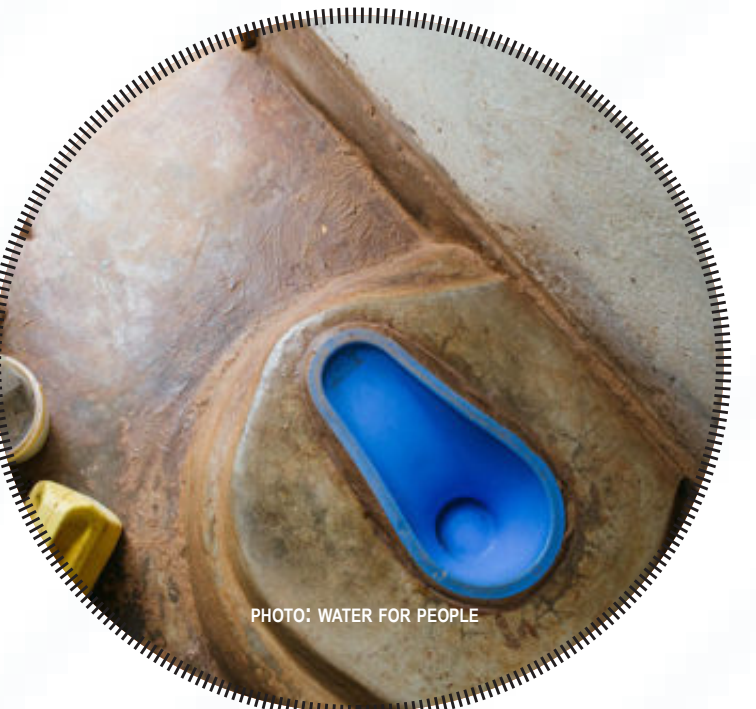
**258**

Household toilets that collapsed during Cyclone Idai

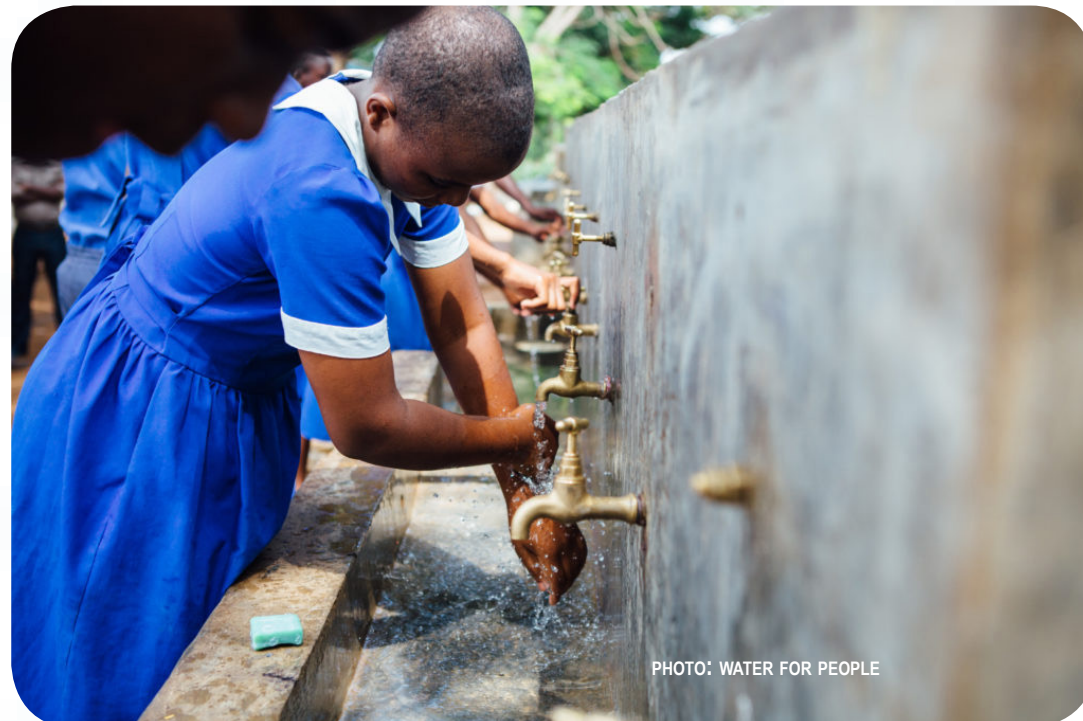
**63%**

Level of water service in 2019 in Chikwawa following Cyclone Idai. this is a significant drop from 86% in 2018

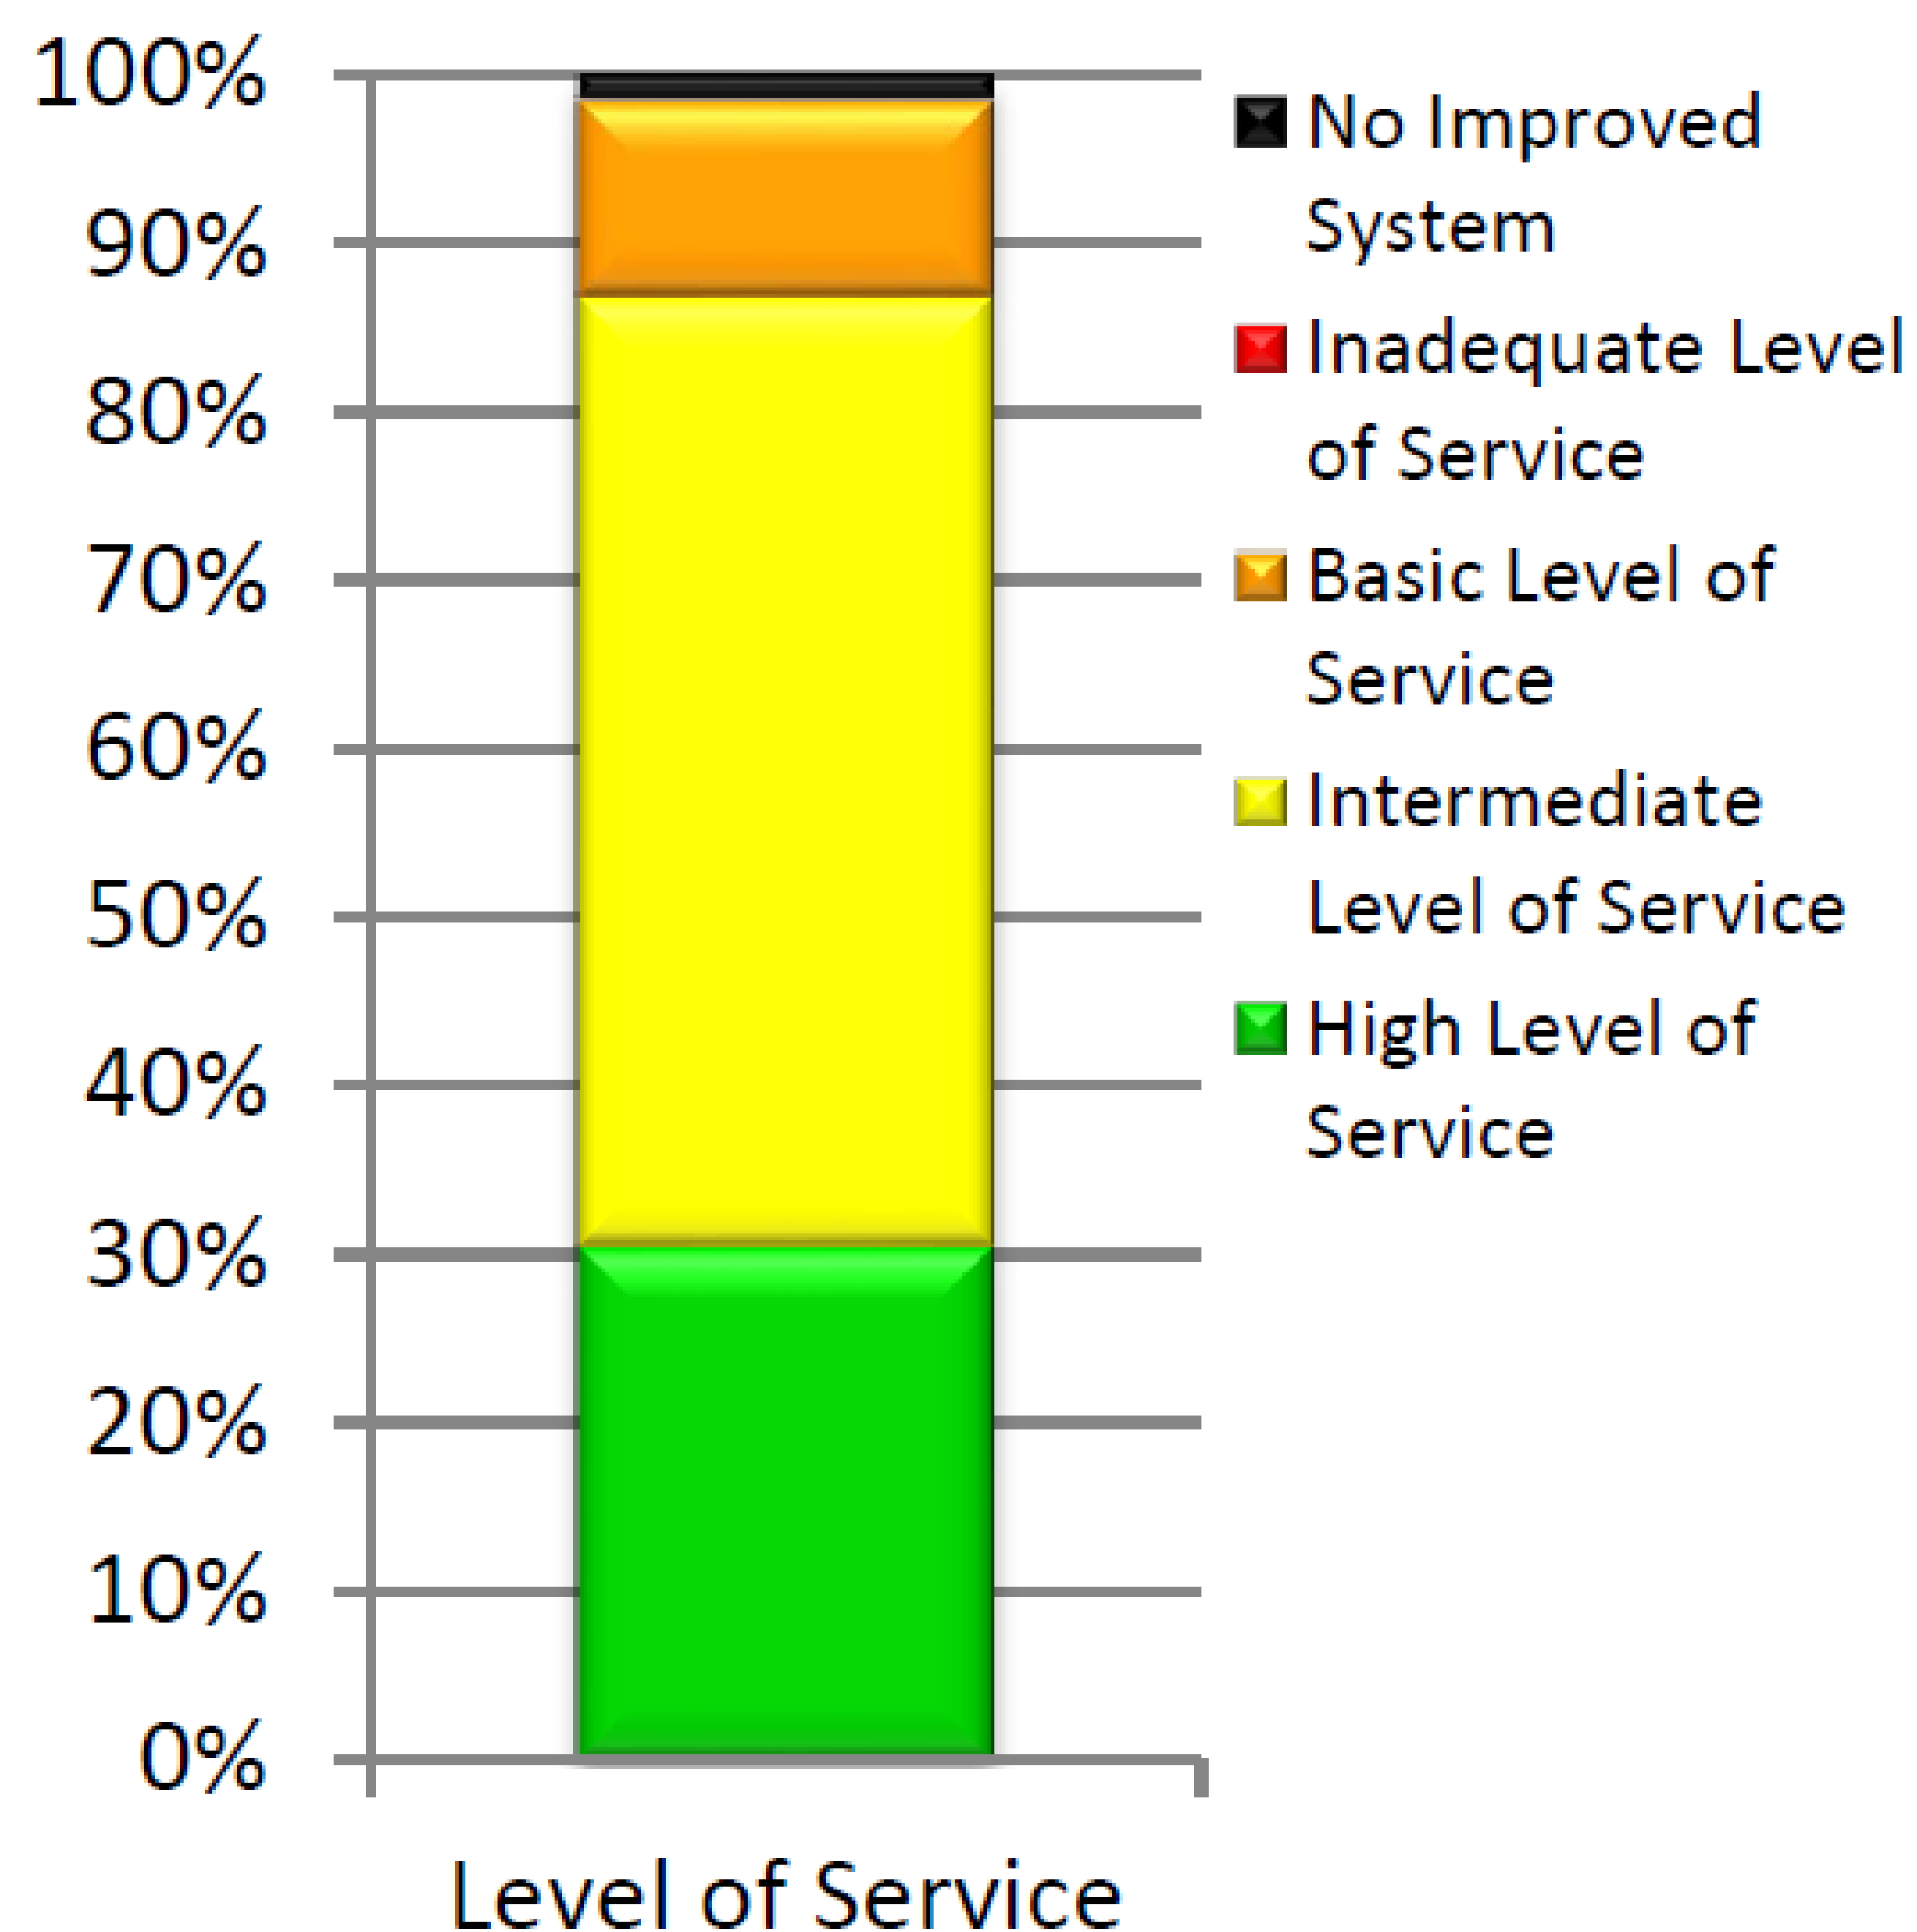
### Chikwawa 2018 Water Point Level of Service
