Lessons, Successes, and Challenges from the Rehabilitation of East Bank GFS

Thokozani Kaitane
April 2021

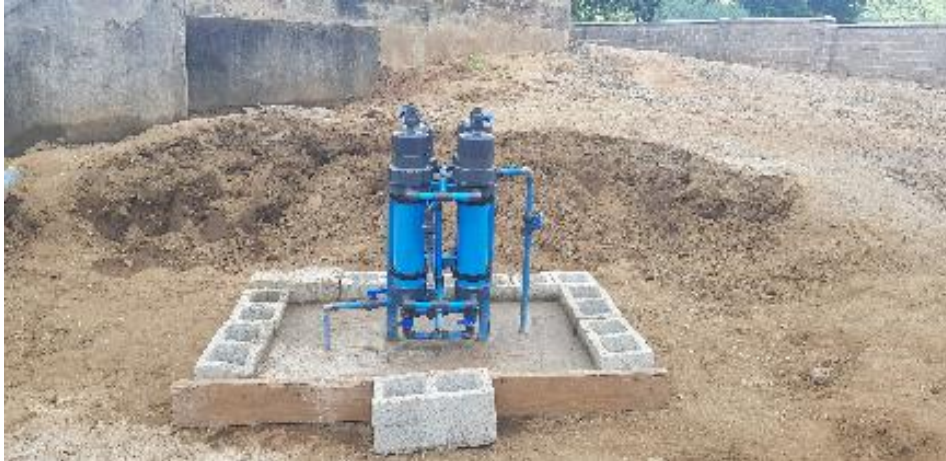
One of the notable successes of the Eastbank GFS is the installation of chlorine dispensers in the two clear water tanks of the system. Water For People noted that there might be some bacteria contamination in the pipelines and decided to boost residual chlorine by installing dispensers.

A chlorine dosing unit at Limphangwi during construction
